# Manhole Inspection Summary

Manhole # S05SS1001MH

**Location** Address: **3500 W NORTHERN PKWY**

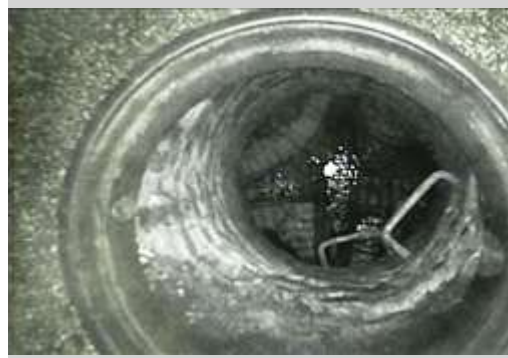
Top View

Frame offset. Channel debris.

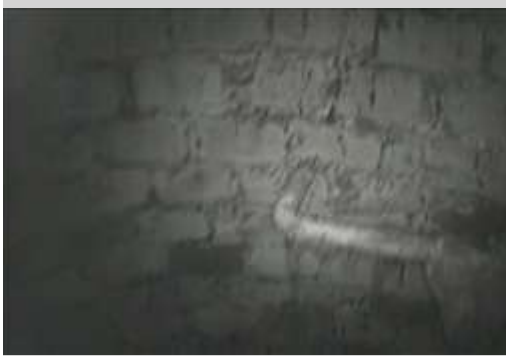
Evidence of surcharge

☒ **Evidence Of Surcharge**

Depth: **7** (ft.) ☐ Active Surcharge Present

Evidence of surcharge.

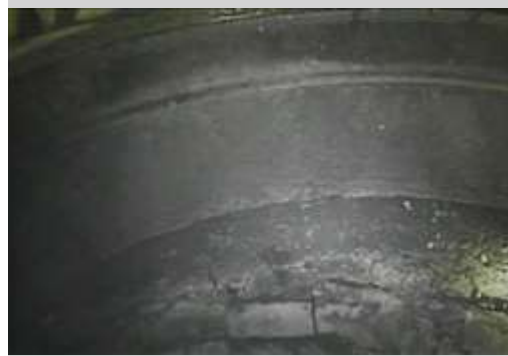
Defect

☒ **Leaks**

Condition: ☐ Sound ☐ Cracked ☐ Root Intrusion ☐ Loose Brick ☒ **Deteriorated**

Infiltration: ☐ None ☒ **Joint** ☐ Cracks ☐ Mortar ☐ Roots ☒ **Wall**

Frame leaks. Adjustment deterioration and infiltration.

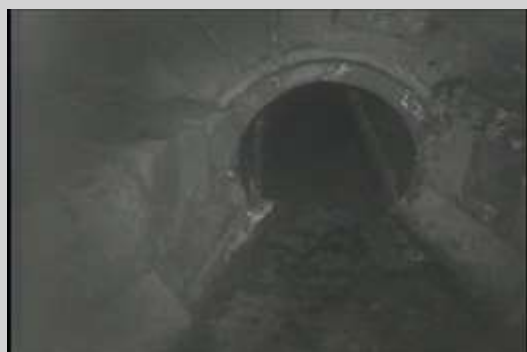
Pipe Out @ 12 O'Clock

Infiltration: **Evidence** Pipe Seal Cond: **Unknown**

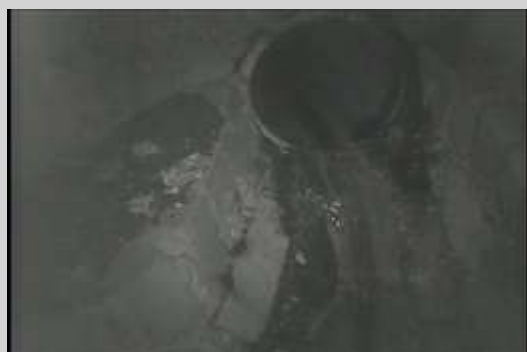
Pipe In @ 3 O'Clock

Infiltration: **Evidence** Pipe Seal Cond: **Unknown**

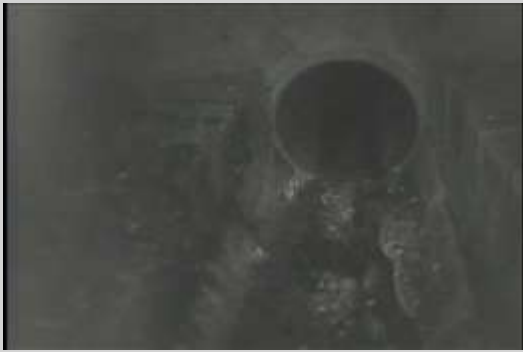
Pipe In @ 6 O'Clock

Infiltration: **None** Pipe Seal Cond: **Cracked**

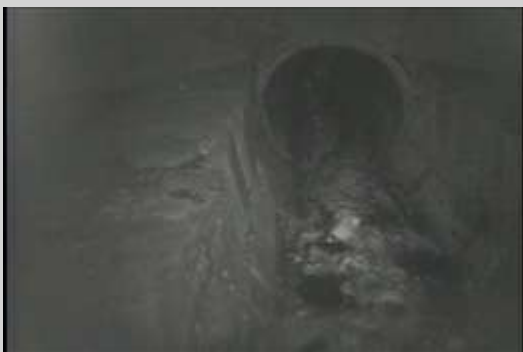
Pipe In @ 9 O'Clock

Deposits: ☐ None ☐ Mud ☐ Sludge ☒ Debris ☒ Grease

Silt Depth: **3** (in.) Deposits Extent: **Light**
